# Navajo Abandoned Uranium Mine

# **Site Screen Report**

## **Section 1 Lease AUM Site**

January 2011

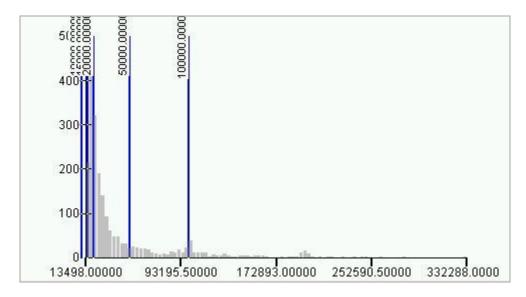
**Mine ID: 454**

332,288 counts per minute (cpm)

A total of 2,108 gamma radiation measurements were collected from the mine site, ranging from 13,498 cpm to 332,288 cpm. The measurements collected at the waste pile were found at a maximum level of approximately 40,000 cpm, and at the exposed ore at a maximum level of approximately 330,000 cpm. The measurements are represented in Figures 1, 2, 3, and 4.

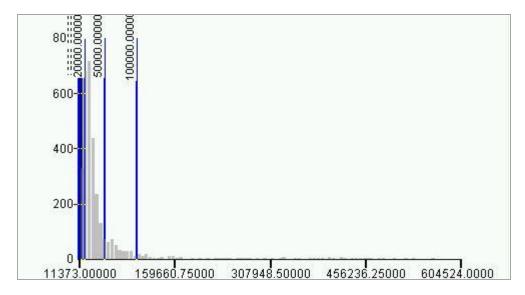
#### **Mine ID: 527**

604,524 counts per minute (cpm)

A total of 3,152 gamma radiation measurements were collected from the mine site, ranging from 11,373 cpm to 604,524 cpm. The measurements collected at the waste piles were found at a maximum level ranging from approximately 150,000 cpm to 600,000 cpm, and at the trench areas at a maximum level ranging from approximately 30,000 cpm to 80,000 cpm. The measurements are represented in Figures 1, 2, 5, and 6.
